## CX30 – Sensor Location & Active Sensor Status Display in ScanLite2

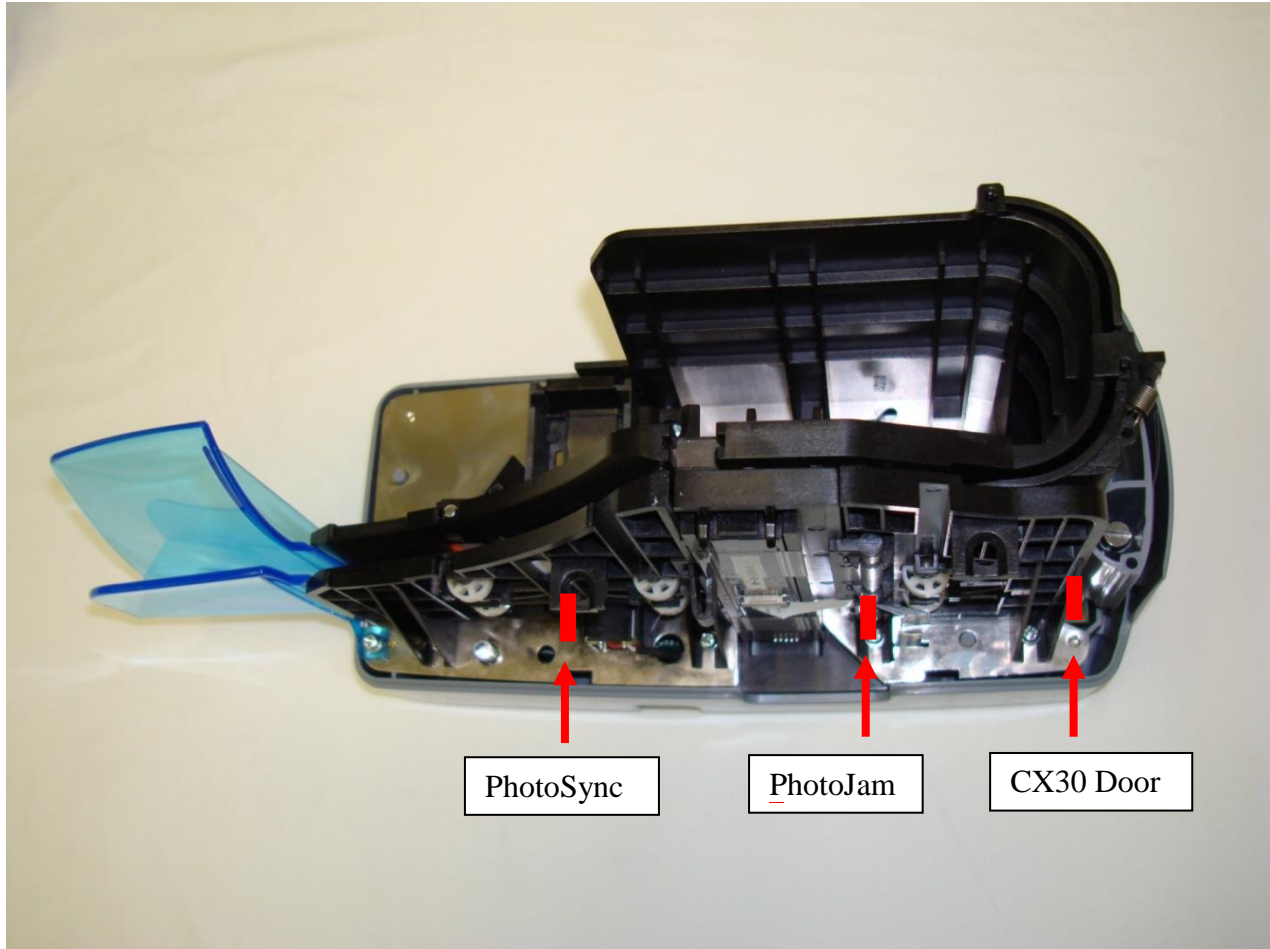
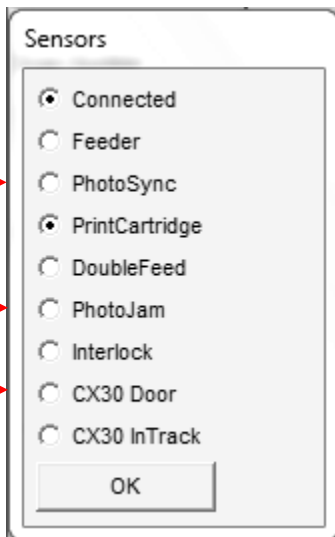
When a sensor is highlighted by the black dot, that indicates the sensor is active.

Default indicators will show **Connected & PrintCartridge** active when the LED is Green and a Cartridge is installed.

**PhotoSync** – Look between the walls for any debris. Blow out with compressed air. If still active, sensor may have failed.

**PhotoJam** – This is the sensor just past the outer camera. Open the outer camera door to check for a paper or debris blocking the sensor.

**CX30 Door** – The Exit door is in the open position or the sensor is blocked.

Typical causes for a 'No Motor Start' condition are:

- There is no ink cartridge present and the application expects to endorse on the rear.
- The PhotoSync or PhotoJam sensor may be blocked or bad.
